LAWRENCE
LIVERMORE
NATIONAL
LABORATORY

System for Detection of Small Inclusions in Large Optics

October 31, 2008

Boulder Damage Symposium
Boulder, CO, United States
September 22, 2008 through September 24, 2008

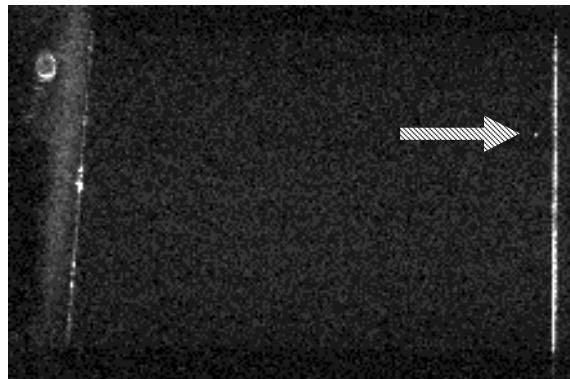
Figure 9: Image of defect as detected by AIM. This defect is too small to resolve with available instrumentation.

Figure 9 shows the image of an bulk defect as detected by the AIM. This defect was previously undetected and is very small. While off line techniques were able to confirm the existence of this defect, none were able to resolve it or provide a reasonable size estimate. Two micron defects have been easily found and resolved; best estimates put this defect at <1 micron.
